Manhole Inspection Summary

Manhole # S13SS1002MH

Location Address: **5101 SUNSET RD**

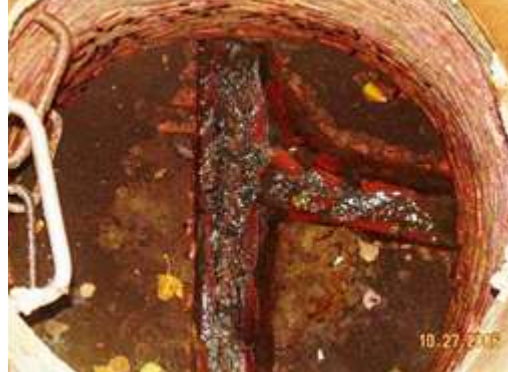
Top View

☒ **Debris** (not Condition related)

☒ **Corroded**

☒ **Evidence Of Surcharge**

Corroded steps. Evidence of surcharge - Bench debris.

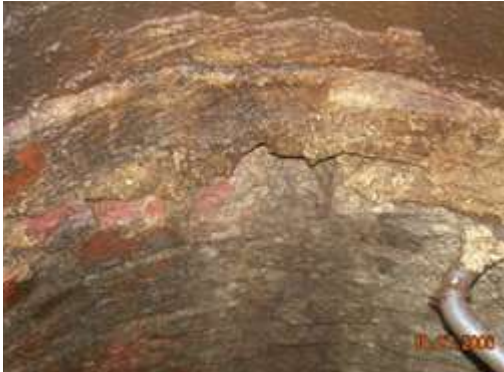
Defect

☒ **Leaks**

Condition: ☐ Sound ☐ Cracked ☐ Root Intrusion ☐ Loose Brick ☒ **Deteriorated**

Infiltration: ☐ None ☒ **Joint** ☐ Cracks ☐ Mortar ☐ Roots ☒ **Wall**

Frame leaks. Adjustment deterioration and infiltration.

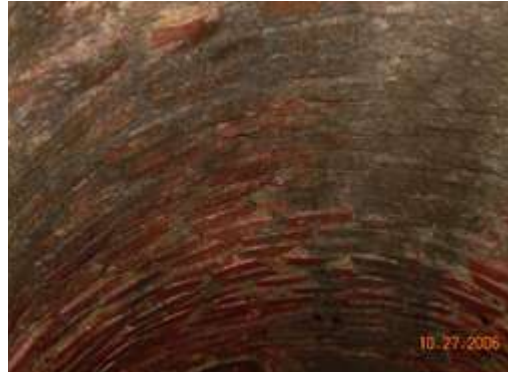
Defect

Adjustment infiltration.

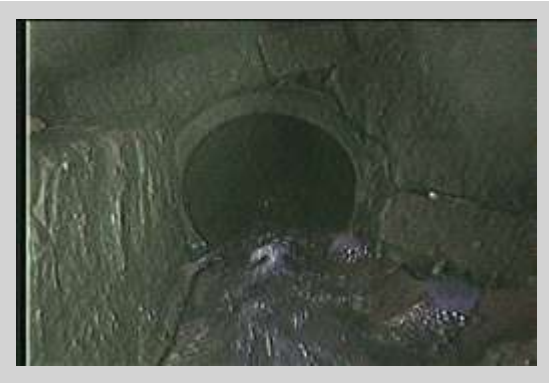
8 in. Circular Gravity Sewer Pipe Out @ 12 O'Clock

Infiltration: **Evidence** Pipe Seal Cond: **Cracked**

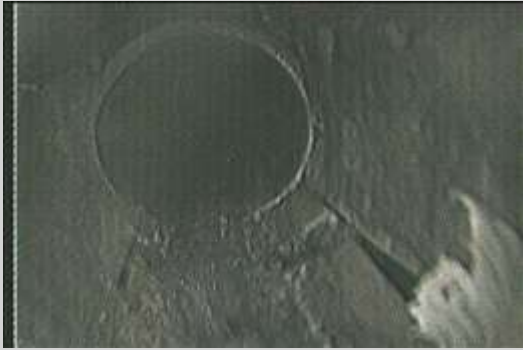
Pipe In @ 6 O'Clock

Channel deterioration.

Infiltration: **Evidence** Pipe Seal Cond: **Cracked**
